WEXCO Industries Unitized Assemblies are only intended to replace units of similar type. Customers building their own wiper systems for a vehicle are not supported or warrantied by WEXCO Industries.

Unitized Assembly Components

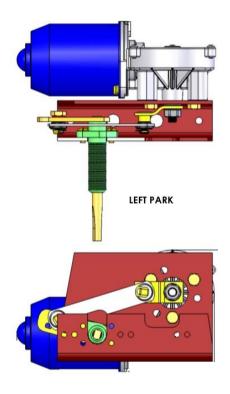
!! IMPORTANT – ensure the motor crank remains in its original parked position when tightening M8 nut. Incorrect park position will result if the crank rotates during this process.
